## Technical Service Bulletin

GROUP CAMPAIGN	NUMBER 12-01-019 - 1
DATE AUGUST 2012	MODEL(S) SONATA (YF) SONATA (YF-HEV)

**SUBJECT** SONATA YF AND YF-HEV CURTAIN AIRBAG (CAB) REPLACEMENT  
(CAMPAIGN 106)

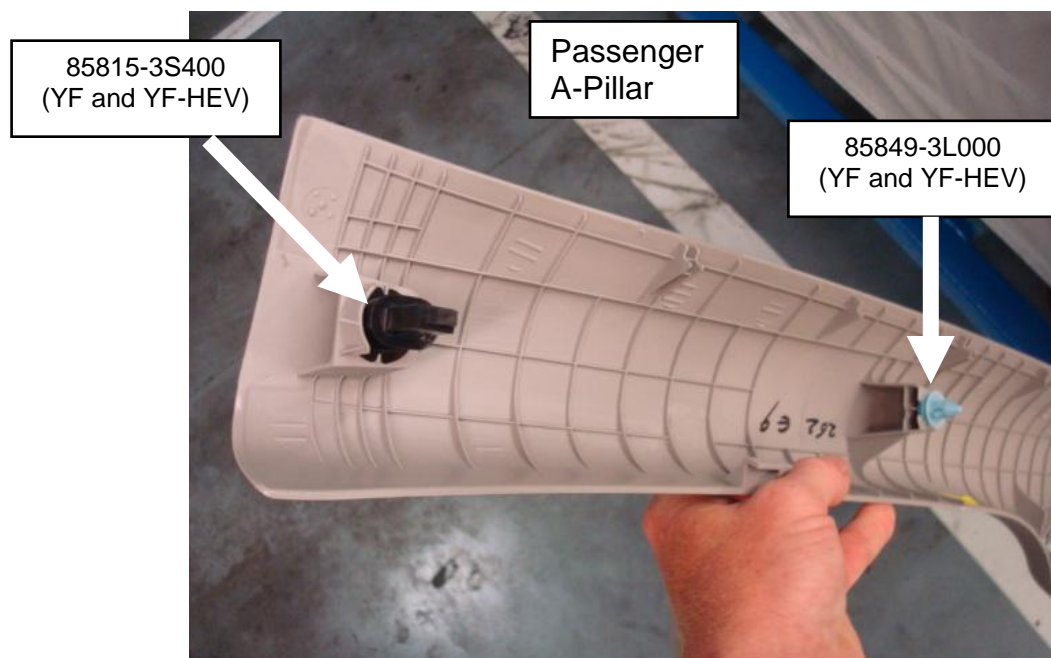
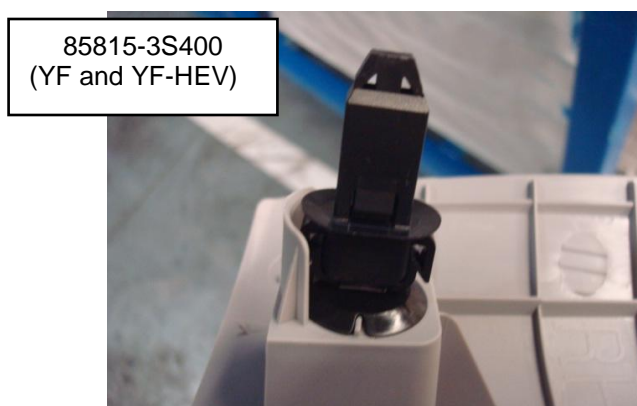
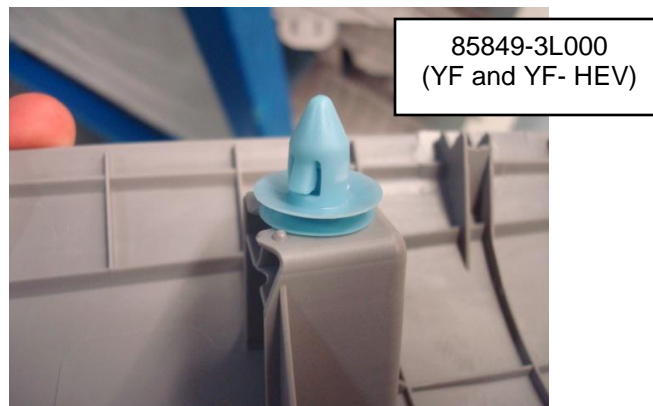
**IMPORTANT:** All repairs regardless of Passenger, Driver or both sides, **must** include two (2) each of 85815-3S400 (apply to both YF and YF-HEV) and four (4) each of 85849-3L000 (apply to both YF and YF-HEV) to replace the clips on the Driver and Passenger A-pillar trim. (See clip locations and images below.)

Occasionally when removing the A-Pillar trim, the small clip (85849-3L000) may separate from its body. Remove the clip body from the A-Pillar sheet metal using a small pick and then replace with a new clip.

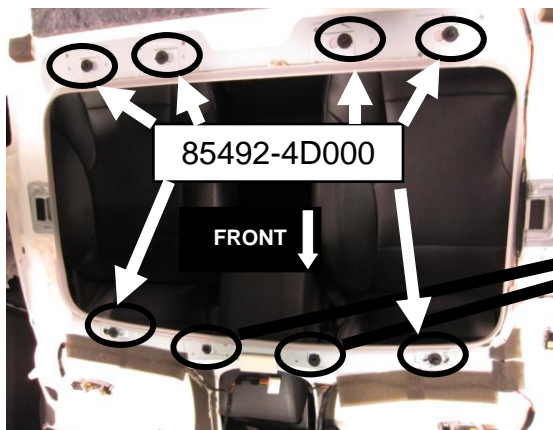
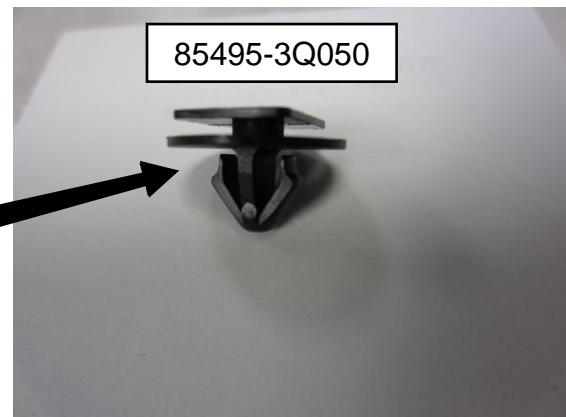
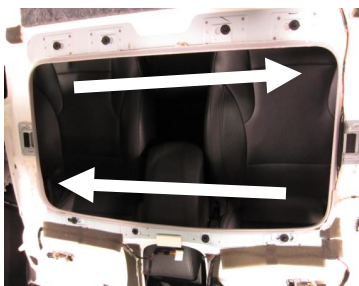
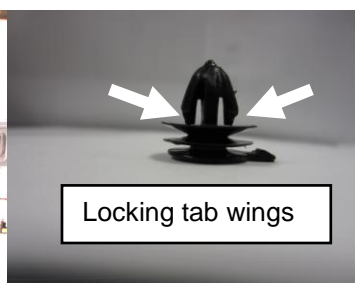
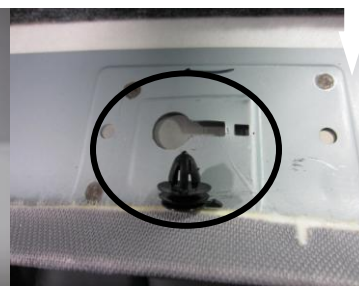
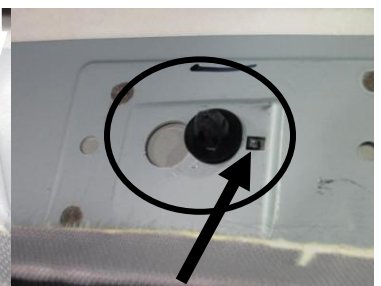
Vehicle equipped with **REGULAR SUNROOF:**

It is very important to ensure all the clips are aligned in the same direction. The two lock tab wings should be in parallel with the sunroof from left to right.

Make sure the clip is inserted in the direction where the arrow tab is locked into place as shown in the picture

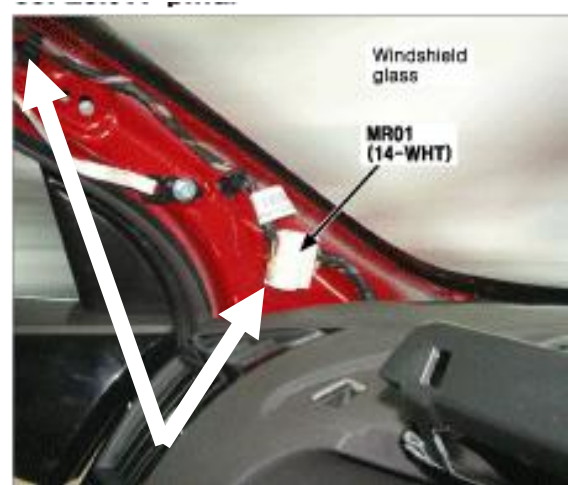
Disconnect connector MR01 at the Driver A-pillar and then remove the Roof Harness clips from the A-pillar.

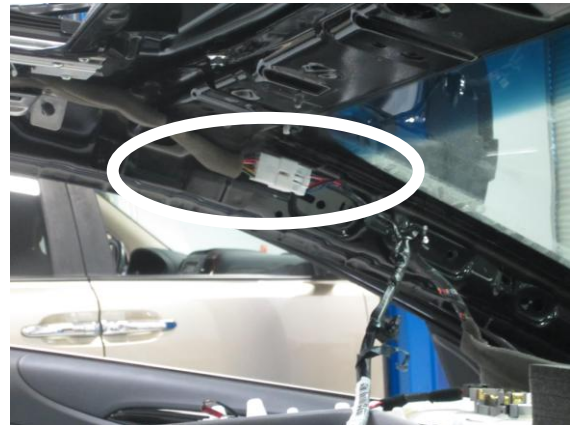
Disconnect the connector on Driver A-pillar head liner.

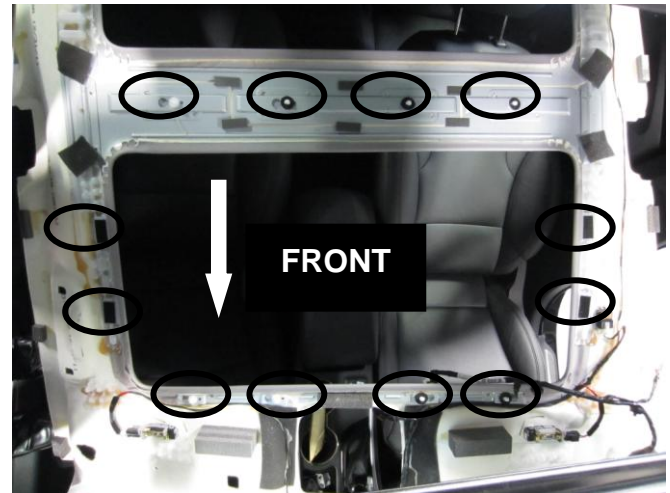
For the vehicle equipped with **PANORAMIC SUNROOF** - Note the mounting clips location along with the velcro.

In the picture to the right, the front of the vehicle is on the bottom.

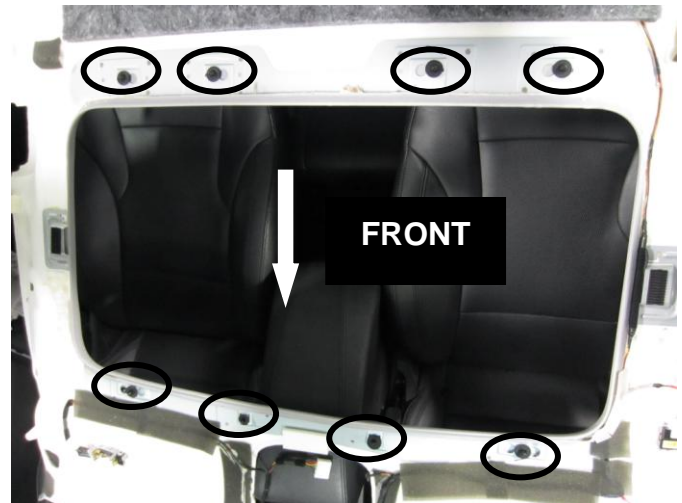
For the vehicle equipped with regular **SUNROOF** - Note the mounting clips location.

In the picture to the right, the front of the vehicle is on the bottom.

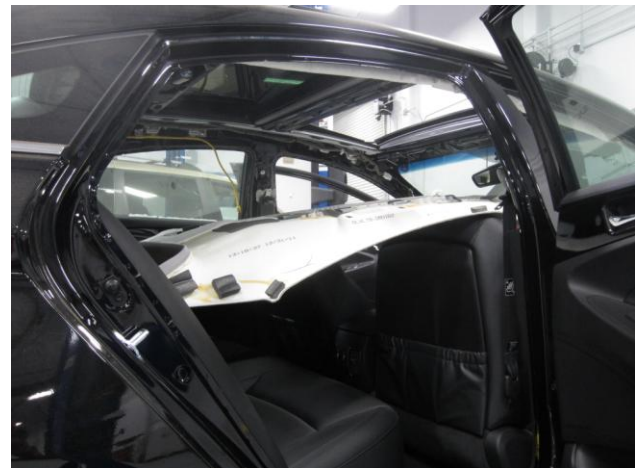
4. Place a protective cover over the dash to avoid permanent markings/scuffings on the dash panel from the corner of the headliner edges.

Remove both the driver and passenger headrest and then lower the headliner.

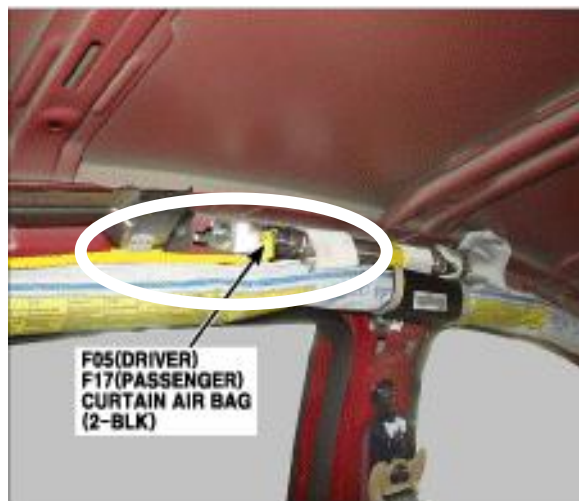
6. Carefully disconnect the Floor Harness connection to CAB inflator canister.
- For Driver CAB, connector F05
  - For Passenger CAB, connector F17

Ensure the locking tab is released prior to separating the connector. Do not pull on the wires to disconnect the harness from CAB.

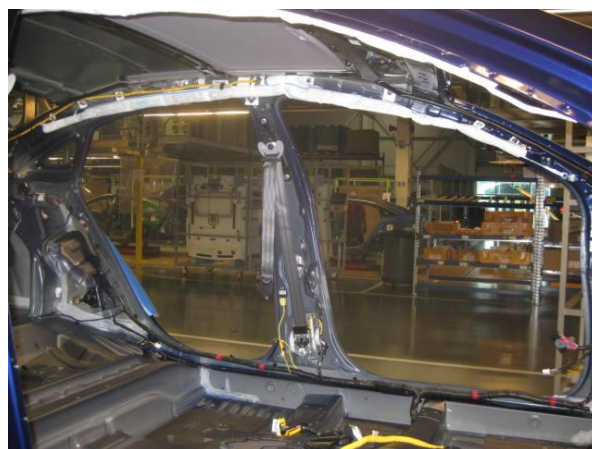
7. Remove all mounting bolts and nuts from the CAB assembly and remove the CAB from the vehicle.

Use caution when removing the CAB from the vehicle to prevent damage to the vehicle.

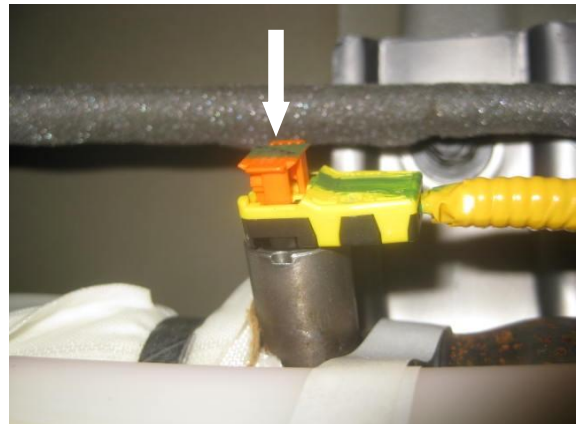
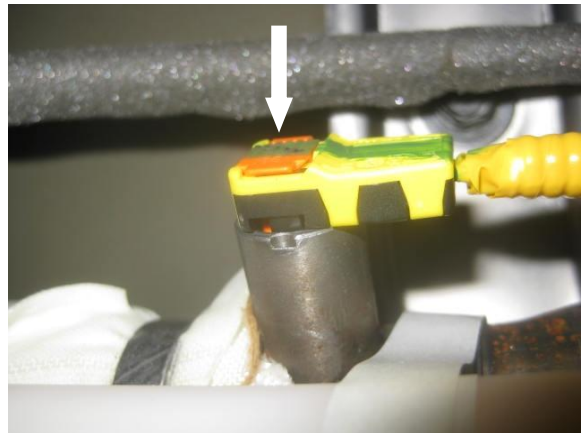
9. Reconnect the CAB connector by seating the yellow portion of the connector followed by pushing on the seating locking tab.

Bolts : 9.8 ~ 14.7 N.m (1.0 ~ 1.5 kgf.m, 7.2 ~ 10.8 lb-ft)

Nuts : 7.8 ~ 11.8 N.m (0.8 ~ 1.2 kgf.m, 5.8 ~ 8.7 lb-ft)

If the secondary lock or connector is not properly engaged, DTC(s) may results.
